TEST REPORT

No.: 123004-2

Cyclic Movement Tests

Customer and Production Plant:	BEMO SYSTEMS GmbH Friedrich-List-Str. 25 74532 Ilshofen-Eckartshausen
Basis of the evaluation:	Order from 03.02.2012
Objectives of the evaluation:	Cyclic movement tests on BEMO-Flat Roof standing seam profile 65/400 with BEMO GFK Halter 165/80

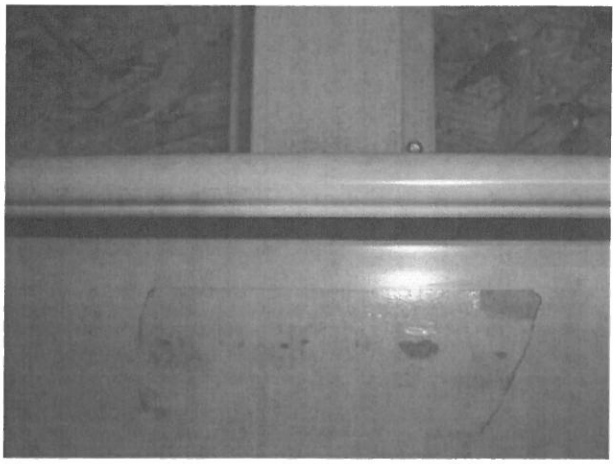
Figure 5.1: Center after test

There was no sign of abrasion on the top side of the top profile (see figure 5.1, annex 5) and on the top side of the bottom profile (see figure 5.2, annex 5). There was some wear on the contact surface of the halter and the panel (see figure 5.3 and 5.4, annex 5).
